**INVESTIGATION OF IMAGE ARCHIVING  
FOR PAVEMENT SURFACE DISTRESS SURVEY**

**MBTC FR-1072**

**Kelvin C.P. Wang and Robert P. Elliott**

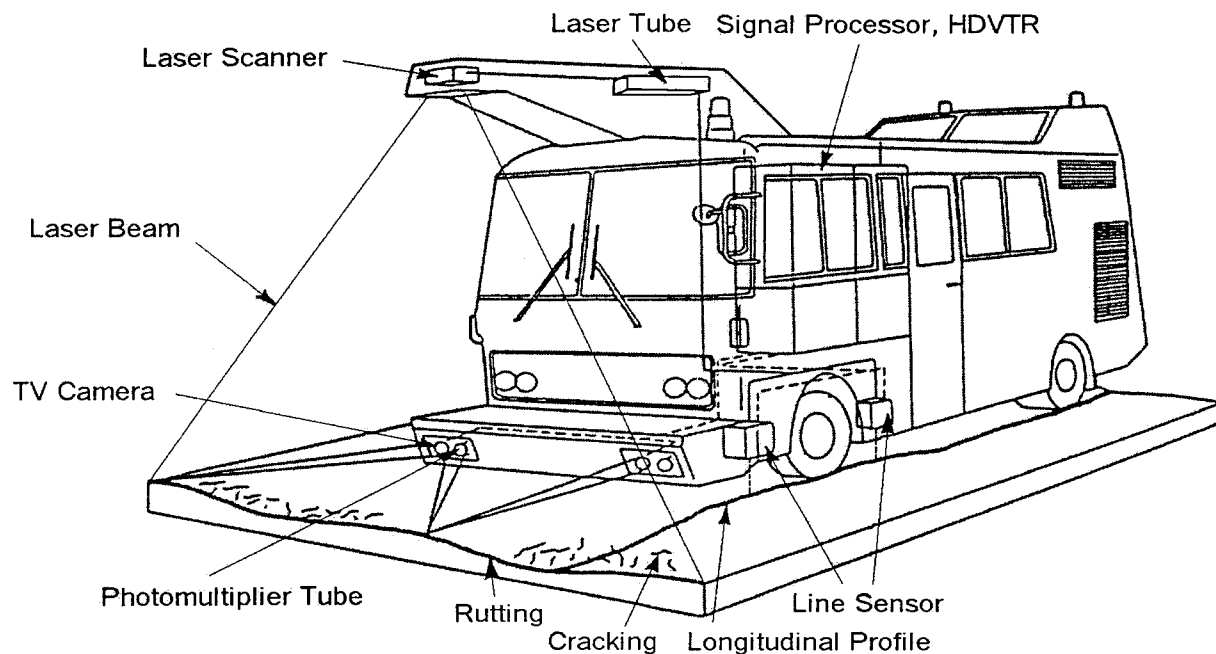
**Figure. 1 Komatsu Survey Vehicle (Based on Fukuhara, T., et al. 1990)**

Komatsu system works only at night to control lighting conditions. Figure. illustrates the basic design of the survey vehicle. When survey is conducted with the moving vehicle, the road surface is illuminated with argon laser light through the laser scanner in the lateral direction. The deflected light from road surface is detected at an angle by a photo multiplier tube (PMT) and a video camera that are attached to the front bumper of the vehicle. When cracks are present on the surface, the quantity of received light by the PMT is reduced. Therefore, the change of output from the PMT indicates the existence of cracks at the scanning position. The video cameras are used to capture rutting, as the scanning line observed from an oblique angle is curvy when rutting is present. The integration of the collected information over time presents cracking and rutting data on the two-dimensional road surface. The longitudinal profile is measured based on the distance between the survey vehicle and the road surface. The profile is calculated based on three sets of data collected at three locations in the vehicle: the first being the rutting measurement, the two others being measurements collected by the two line sensors under the body of the vehicle shown in Figure 1. The data storage devices include a High Density Video Tape Recorder (HDVTR) at the data rate of 100 Mega bits per second (Mbps), and a general purpose Video Tape Recorder (VTR). Pavement surface images are archived with the HDVTR. Digital image processing techniques are applied to crack image data in a post-processing mode. Parallel processing is used at two stages to determine cracking parameters such as the number, width, and length of cracks, which are then stored in the pavement data bank.

In the first processing stage (image segmentation), a massive 64 MC68020 parallel microprocessors are used. The MC68020 is also called the Extracting Processor (EP), the performance of which is equivalent to that of an entry level Intel 386 chip. The system design permits up to 512 EPs to be used in parallel to further improve performance. In segment extraction, the image is divided into 32-pixel by 32-pixel square areas, called slits. A value of a curve is an average gray level of pixel series in the projected direction in the slit. Pixels in a dark area, such as the presence of a crack, have higher levels in the gray scale. In order to determine the angle, the length, and width of the crack in a slit, it is necessary to rotate the projection directions in the image until a peak of the crack appears, indicating that the actual width of the crack is found. The portion of the crack that is contained in the slit is represented by a rectangular element. Each of the MC68020 processor is used to process one slit at a time in parallel with all other processors. After the processing, all found cracks are represented by segmented slits.

In the second stage (crack connectivity), seven T800 transputers are used in parallel to determine the connectivity among the extracted segments, and eliminate noises. The connectivity is determined by the relative positions of cracks in neighboring segments. The transputers produce a line image of the pavement surface, or a crack map.

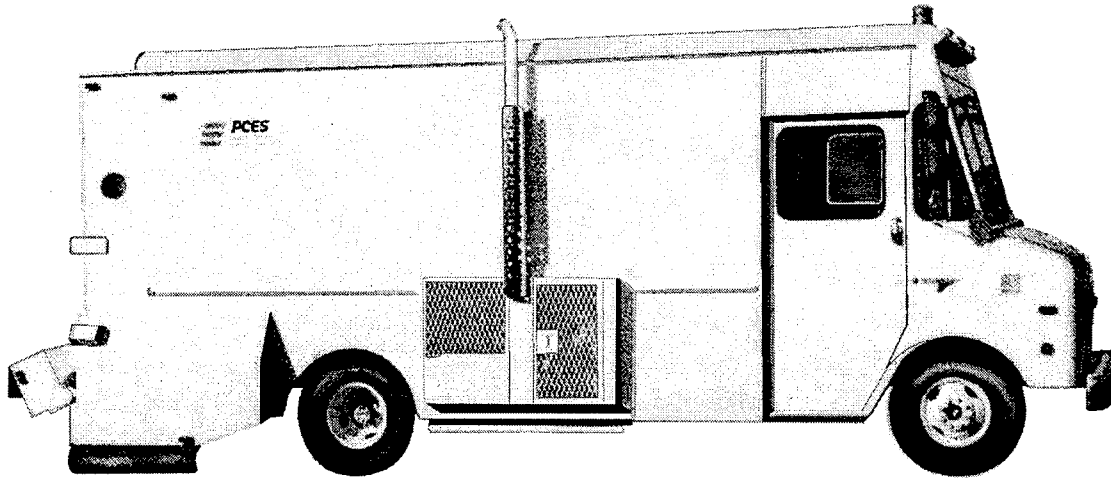
**Figure 2 PCES Survey Vehicle**

The developed vehicle is shown in Figure 2. The vehicle is a 21-foot Grumman truck body, which contains space for all system hardware, and operating console and an observer station. Two 15-kilowatt diesel generators power the computer, lighting and other equipment. It should be noted that in order to obtain lines of images at required speed, line-scan cameras need much higher intensity lighting than conventional area-scan cameras. The lighting from the PCES system could burn the asphalt surface if it directed on the same areas for a few minutes.

In the PCES system, digital signal processing was used in real-time, using custom-made filter circuits, which are 3 x 3 neighborhood convolver boards. The boards contain special processors with built-in imaging algorithms to filter images very quickly. Each of the two 512-element line-scan cameras continuously covers four-foot pavement, for a total of eight feet of pavement width. Each camera is supported by an 8-bit analog-to-digital converter, a convolver board, and a 68020 processor. An additional 68020 processor supervises the system activity. The system was intended for daylight use throughout a normal range of highway speeds.

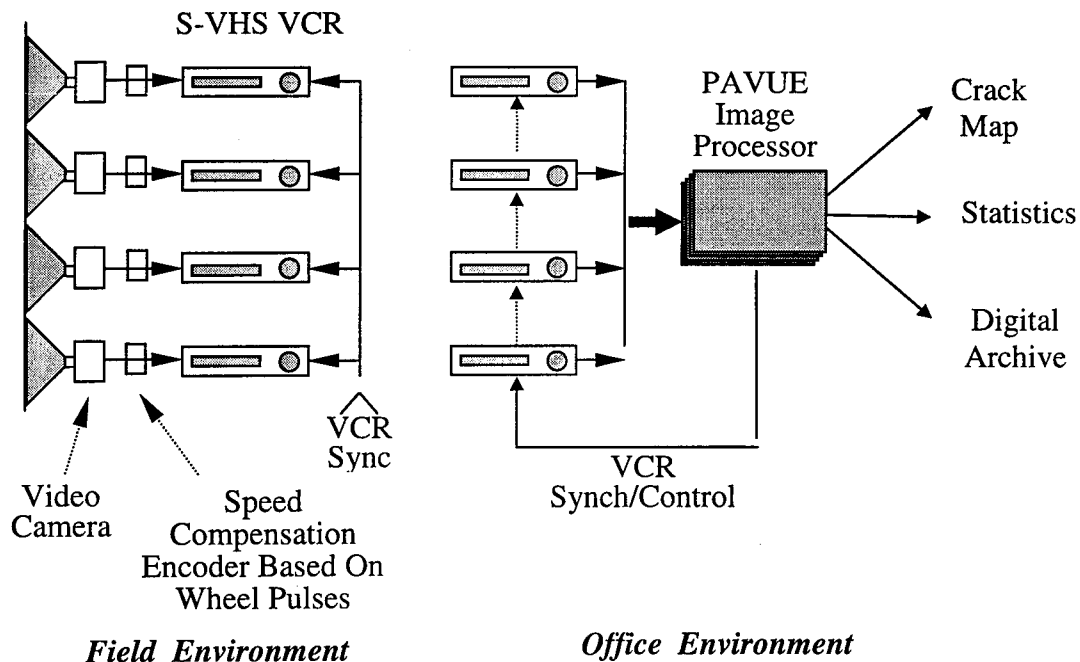
**Figure 3 Data Flow in IMS's PAVUE System (based on IMS literature, 1996)**

Figure 3 illustrates the data flow of the PAVUE system. Each of the four video cameras cover about one-fourth of the pavement surface, resulting in the resolution about 1,400 pixels per lane. The speed compensation device allows the van to drive at any speed between 5 - 55 mph to ensure continuous video image with uniform resolution in both longitudinal and lateral directions. The detectable size crack is about 2.5 mm (1/8 inch). A strobe lighting system is also used.

The unique feature of the PAVUE system is with its image processor boards. A total of twelve different VME based boards were developed by IMS to form the core of the image processing. A total of 80 boards can be used in a full PAVUE processor system. The boards were constructed with a combination of various customized and off-the-shelf circuits. Image processing algorithms were also coded in hardware to speed up the processing.

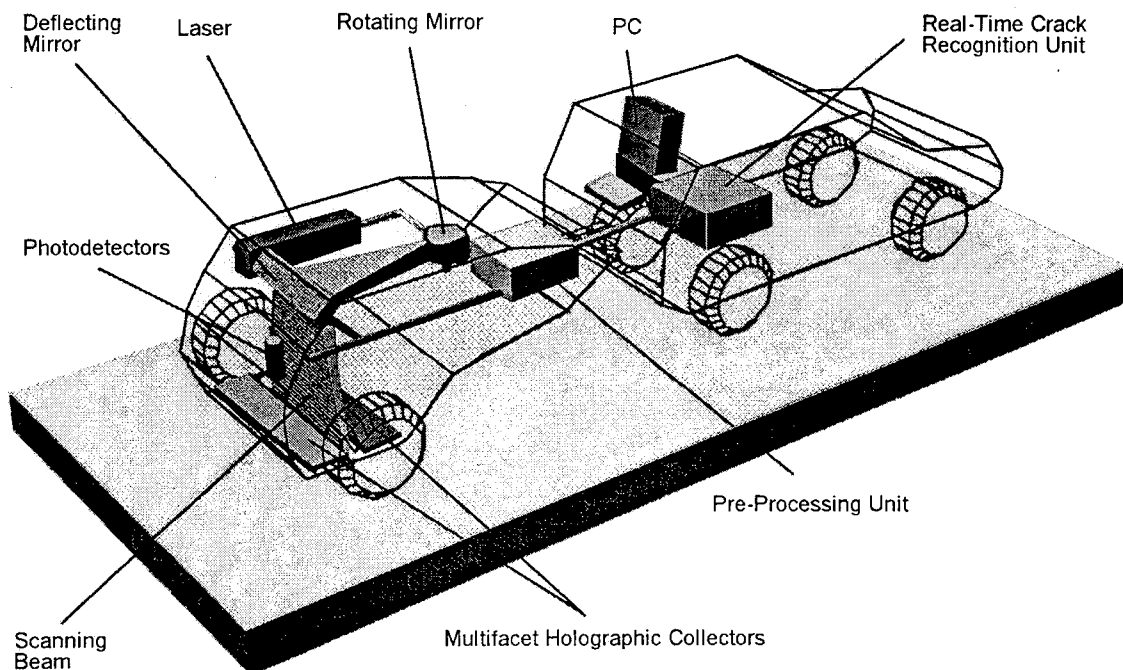
**Figure 4 CREHOS Survey Vehicle (Based on Max Monti, 1995)**

The developed system is called Crack Recognition Holographic System, or CREHOS. With this system, the pavement surface is scanned with a focused laser beam along a straight line in the lateral direction, while the longitudinal scan is conducted with the movement of the vehicle. The reflected light from the surface is collected with a collector, which was a customized holographic element. When the laser light falls into a crack, the strength of the signal collected by the holographic element decreases. This signal is filtered and binarized to obtain sets of binary pulses representing the crack. These sets of data are then formatted, pre-processed, and stored at real-time with a parallel processor.

The processing unit, a parallel processor, was built for CREHOS to further filter noise, recognize cracks, and vectorizes their shapes at real-time. This parallel processor consists of a number of tracking units, or processing units, each of which works on a single crack-representing pulse at one time. It should be noted that the processing units are not the same as conventional digital microprocessors. They are simple electronic devices based on analog technology and with the capability of identifying crack-representing pulses. Each tracking unit can complete processing in every very  $80 \mu s$ , which is about the duration of scanning one line. Both the Komatsu system and CREHOS use laser scanning to obtain pavement distress data. This is where the similarity ends. CREHOS applies analog approaches to data collection and pre-processing. In addition, the parallel processing is unique that no actual digital microprocessors were used. CREHOS was constructed in a research environment. The effort did not produce a commercial system.

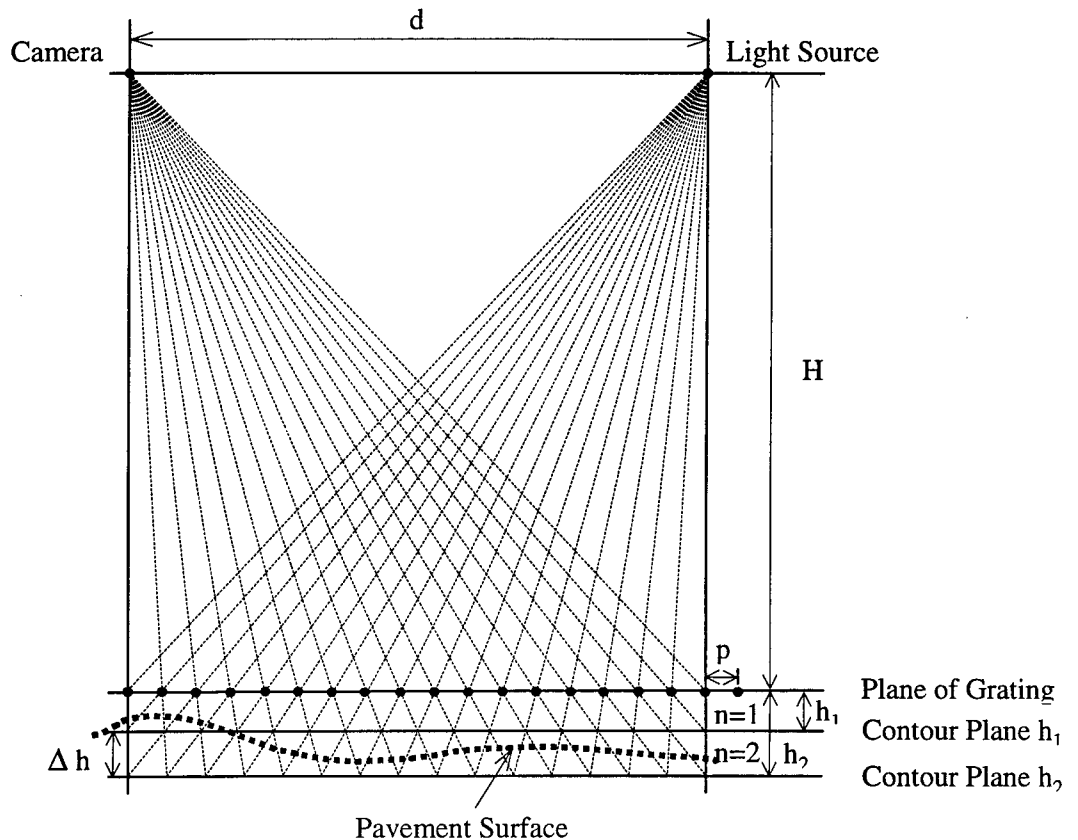
**Figure 5 Demonstration of the Shadow Moire Method**

The shadow Moire method is demonstrated in Figure 5. Both the light source and the camera are placed at the same observing plane and at a distance of  $d$  from each other. The grating plane is parallel to the observing plane. The distance between both planes is  $H$ . The spacing of the black grating lines is  $p$ . Contour planes,  $h_n$ , are generated by the intersection of the projected lines from the light source and the sight lines from the camera's position. The contour interval,  $\Delta h$ , can be approximately expressed as:

$$\Delta h = p \frac{H}{d} \quad (1)$$

Based on this known  $\Delta h$  and the contour map, which is created through the shadow cast by the light source through the grating lines on the pavement surface, a digital terrain surface of the pavement is then established. Through the analysis of this terrain surface,
